Saga of Hall sensors of BMW R1100

My saga of Hall sensors (Nth story but perhaps THE issue)

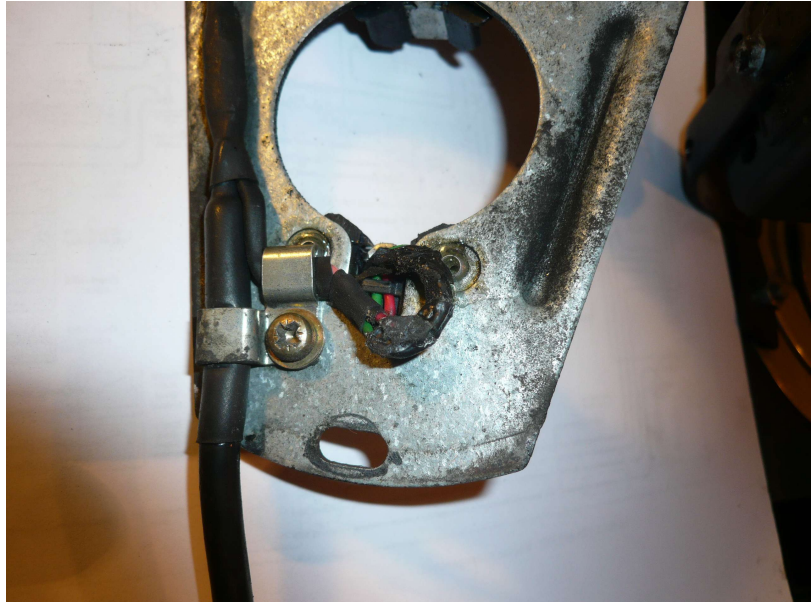
O surprise, this tape has been damaged, as melted: So it's hot on board !

we see black deposits while the plate was cleaned during the repair

There are black marks on the wire, which seem to follow the scales: probably dust, sludge and metal particles. But the cell holder plate is in an environment of deposits, see picture of the plate.

- each cooling, air enters the cable draining dust and metal particles from close environment, forming a sludge between the scales of PVC, we see these deposits on the picture of the underside of the plate.

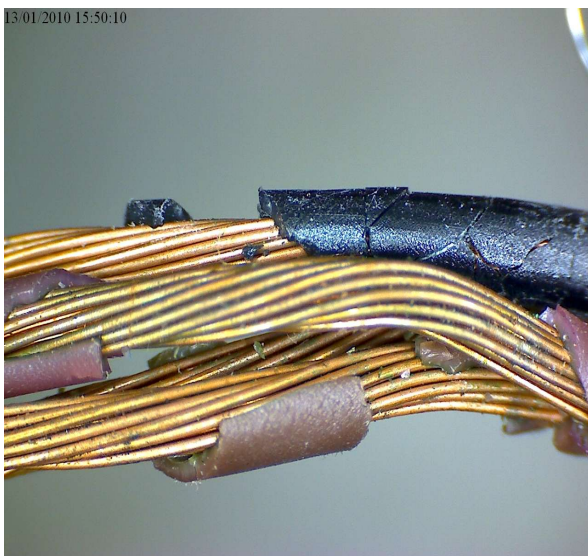
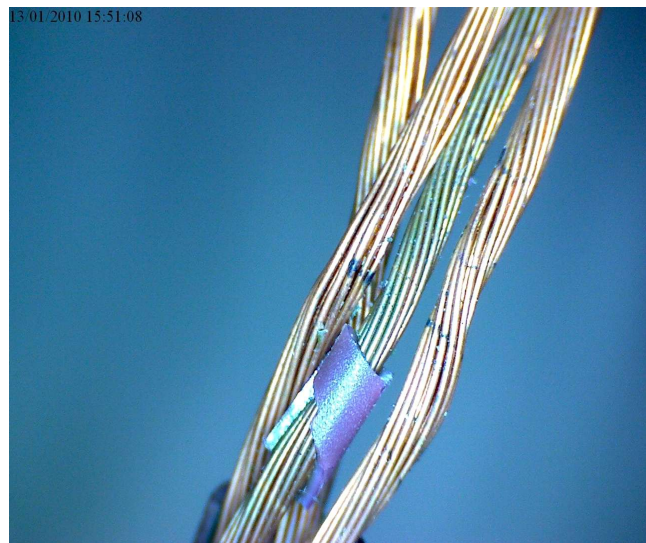
The plastic of the wire (probably PVC which withstands 70 ° C) is cracked and the scales falls from the wire as soon as we move the cable.

- PVC changes with age, and very differently depending on the climate of the place (local temperature and humidity).
- at each change of temperature, the air contained in the cable expands and retracts: an effect of heat pump. An aggravating factor is the wire floating in a (beautiful) sheath, which leaves room for a significant volume of air, aggravating the problem.

- this sludge ends up being conductive and pollutes the electrical signal from the sensor.
- this phenomenon is sensitive to temperature, humidity, perhaps even to the altitude, and requires "some time" to trigger or disappear! It looks very close to all my troubles.

The cause of the problems is the bad choice of the wire by BMW, inadequate to the conditions of use, and of aging.

I put the wire from a computer cable and stamped 115 ° C, it is not in that garbage of BMW PVC, **AND** does not flake off over time, **AND** withstands much better the temperature. I lazily preferred this solution, rather than changing the passage of the oil pipe.

I URGES CHANGE of CABLE (CABLE and NATURE of , NO MORE GENUINE BMW CABLE !) BETWEEN THE SENSOR AND THE CONNECTOR, but the sensors may remain (they last the length of the machine on the BMW K series and on cars)
