## 1) Failed regulator Selectronic N°1

### 1.1) Selectronic claim

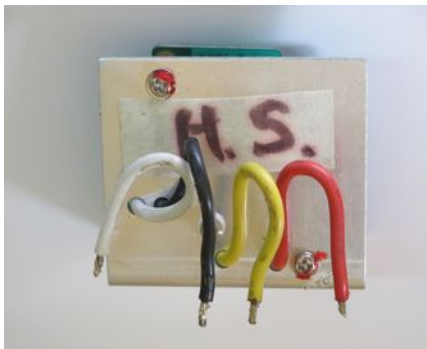
External view of radiator

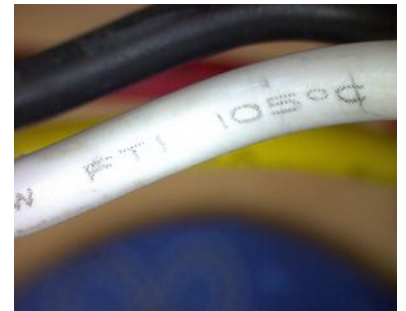
All wires are wounded by the radiator (not deburred) but the wires are too big to go into the PCB holes, they are soldered butt to the PCB, with various angle at the radiator.

All wires are wounded by the radiator (not deburred on one side, fortunately, on this sample on inner side, where the wire moves less). Because the wires are NOT going through the PCB, the angle at the radiator varies, and the contact with the radiator may be hard.

#### **RECOMMENDATION = bond the wires to the PCB and to the radiator,**

Ideally, the wire should have a stress relaxing loop. Anyway the holes HAVE to be big enough or redrilled (in this case, solder on both sides) .

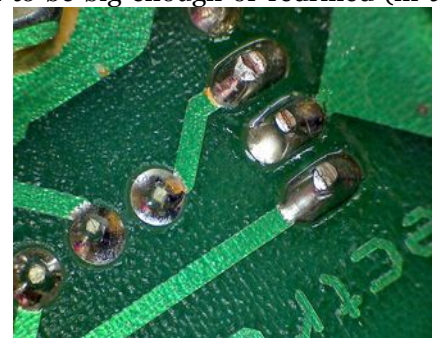
- Correct solder except big wires
- leaded solder (probably illegal for sale since 2006)

The solder flux residues are cleaned on the PCB, except for added elements, probably added in a second phase of manufacturing : big wires and TO220 transistors. This may induce long term corrosion problem and moisture sensitivity. NOT CONFORM anyway, but probably not so important here because of the presence of solder mask and no high impedance circuitry

No wire goes through the PCB because the copper diameter is bigger than the hole ! So, the wires are butt soldered and not centered.

A traction stress is not welcome here ! NOT CONFORM

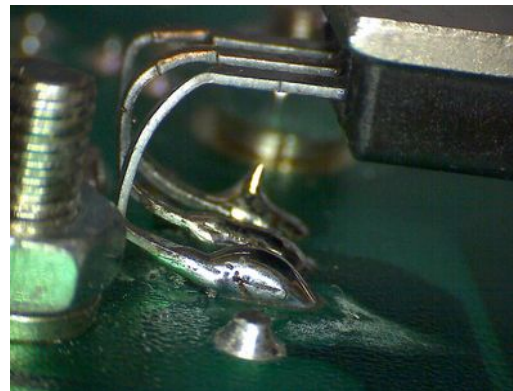
An example of more tolerant mounting of the transistor.  
This one was not a new one, that explains the irregularities.  
This transistor, was only used for checking the hypothesis of single failure.

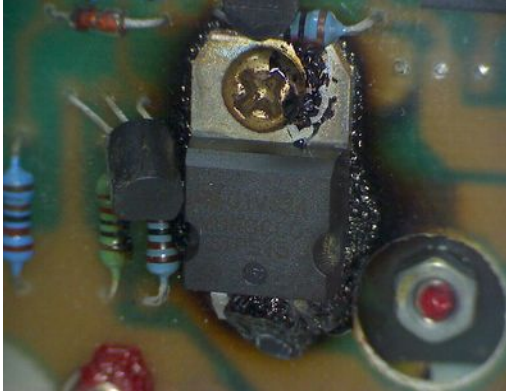
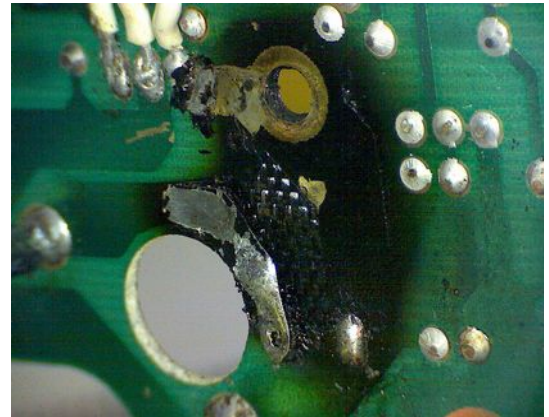
Catastrophic result, visible to naked eye, with characteristic smell of « burnt electronics ». But it is only the PCB which apparently suffered. Copper tracks separated from the rest of PCB, migration of solder underneath, it means that the temperature went over 183°C (because I suspect the use of tin-lead solder) Anyway the temperature of the diode never should have been over 175°C.

Of course, the diode is dead, showing unstable resistance from .1 to 10 ohms, both directions.

**The diode is totally unable to work at nominal 8.5A dynamo current with its genuine mounting**

It's even destructive and now the battery current flows to the armature with great risk of burning it.

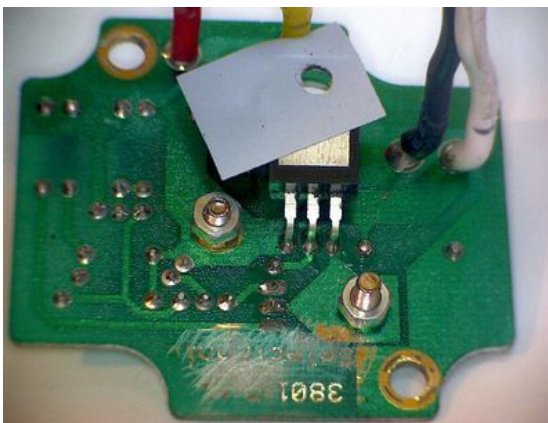
bad placement of silicon sheet  
unexplained scratching of solder mask

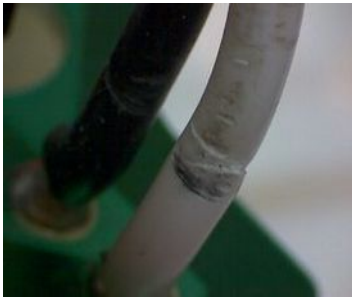
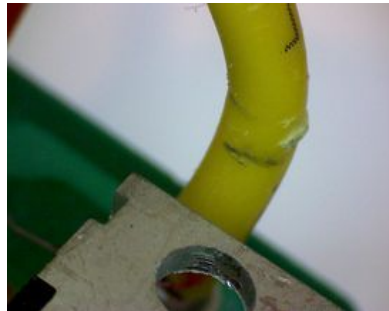
wounded wires on radiator thru-going :

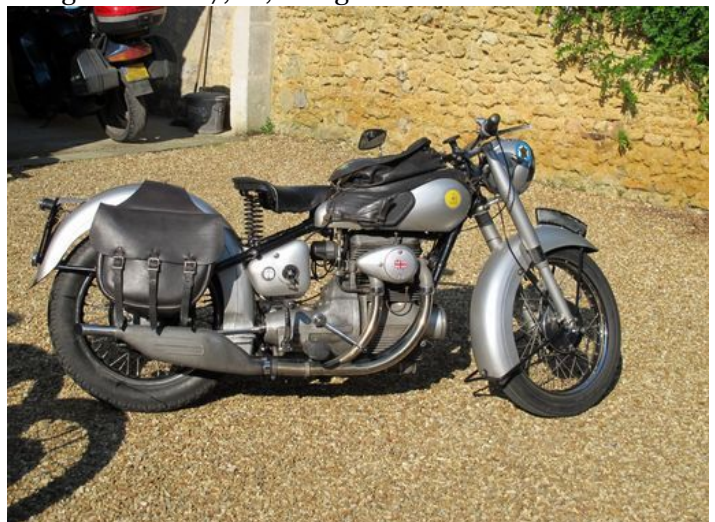
The regulator is mounted on a S8 Sunbeam 1952 built, Lacas dynamo 6V 60W, withstand hours, at air temp of 30°C

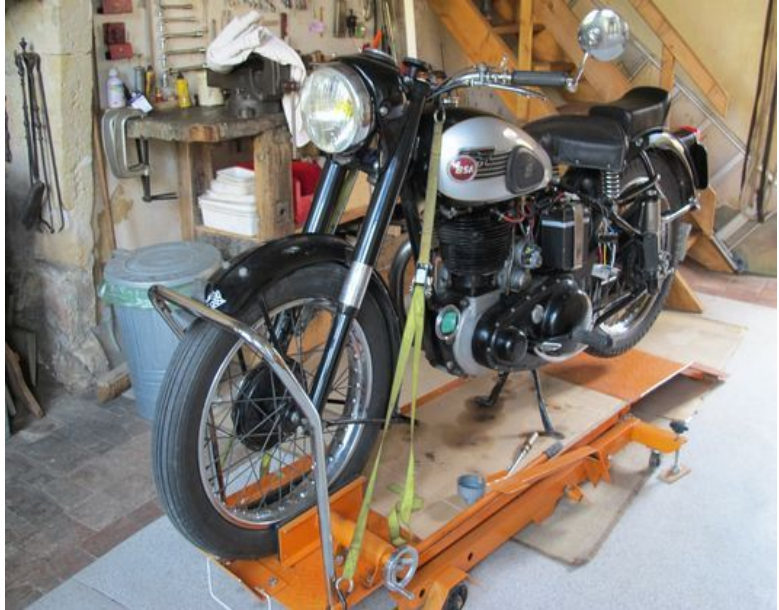
Mounted on BSA 350, 1954

works just fine

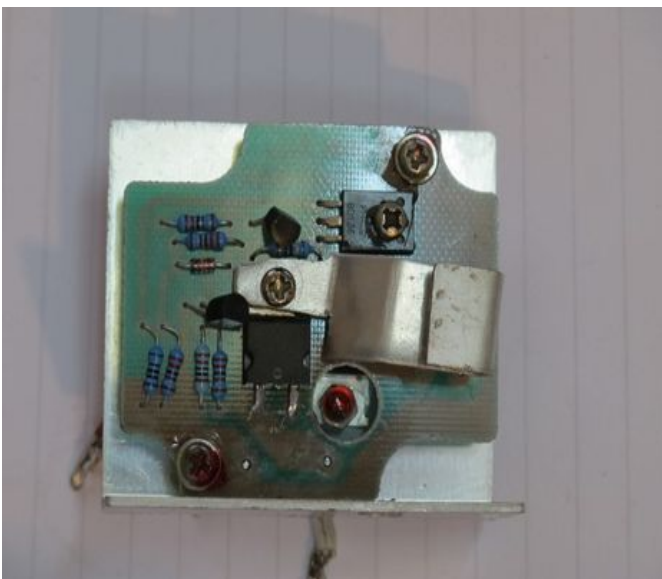
### 6) Regulator # 06 (Fred)

Regulator is actually on MCR2 base, I observed tha one component was heating a lot, I added a small radiator  
**point 1** probably not with state of the art rules. In fact it worked for around 450km

After 400km the old armature burnt out and lamps burnt, like chromated inside **point 2**

after 50 more km, new armature burnt out and alive regulator

**point 14** I realized the D1 overheating by opening the case : smells burnt electronics, my fingers felt the overheating of D1. After installing mini-radiator, I felt D1 still hot but much mower, all observed in lo-light

The printed circuit is parallel to the radiator, wires are straight, slightly wounded (no consequences yet to the failure). Transistor TIP41 directly mounted (no wires), withstanded failure.

Fred overloads dynamo with 45W lamps, this alone is not catastrophic, the dynamo may survive  
 this regulator was modified for protecting diode D1, but his output voltage , the higher of thos I have tested, was not corrected and caused important damages  
 lamps with short lifespan (10 hours)  
 important charging current in an already fully loaded battery  
 important current for the dynamo, caused destruction of 2 armatures

I keep my recommendation to replace D1 by a MBR1545 and putting his wo internal diodes in parallel, to fix it to the main radiator, and to connect it by wires to the PCB.

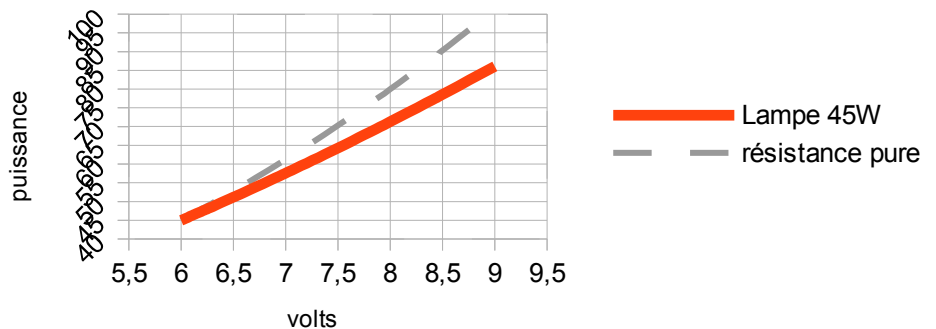
puissance lampes 45W

With 45W, Fred overloads the dynamo by 55 %

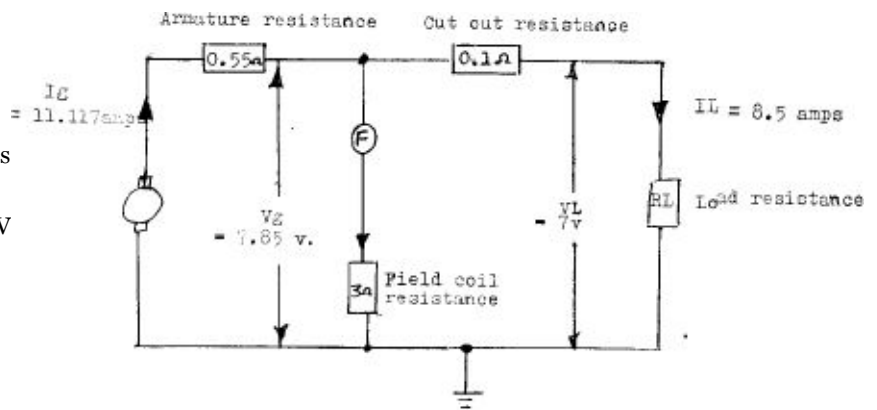
main information : systems works with 7V battery and 7,85V dynamo out (anf field coil in)

**Overloading is now 148W !!**

This overloading, due to Selectronic lack of accuracy, requests an over power of 300 % from dynamo. This a sufficient explanation of armature destruction

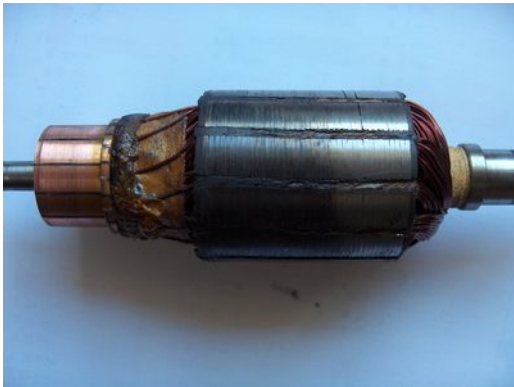
Fred's poor armature !

Blueished iron , molted solder spots, shows an impressive overloading

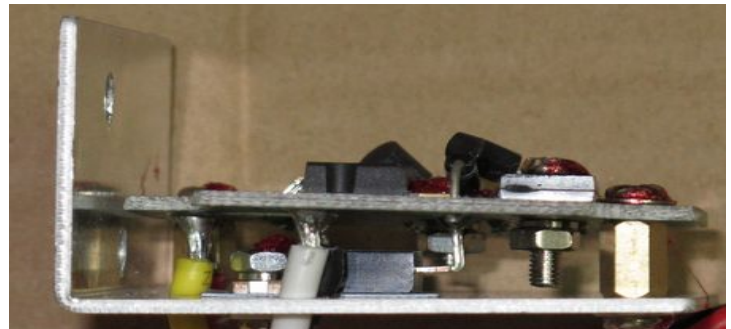
Received DOA T1 transistor ha two cut leads  
 zener voltage is 5,70V

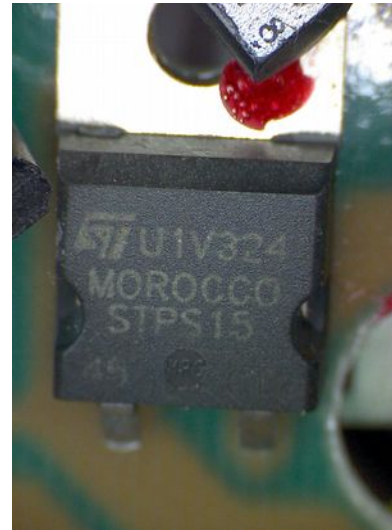
In addition to all problemes listed, the infamous diode caused new problem. Some diodes sold by Selectronic, labelled ST, are not conform to the datasheet. The package is TO-220, the datasheet shows no connection on the radiator an anode & cathode connected to the pins (standard case). The D2PACK package has the radiator connected to the cathode (K) and no connection to the left pin (NC), this exactly the pinout of the TO-220AC package sold by Selectronic.
